# Your Inspection Report

Vancouver Island  
City, BC

**INSPECTION DATE:**  
Thursday, February 1, 2024

**PREPARED BY:**  
Terry Marquis

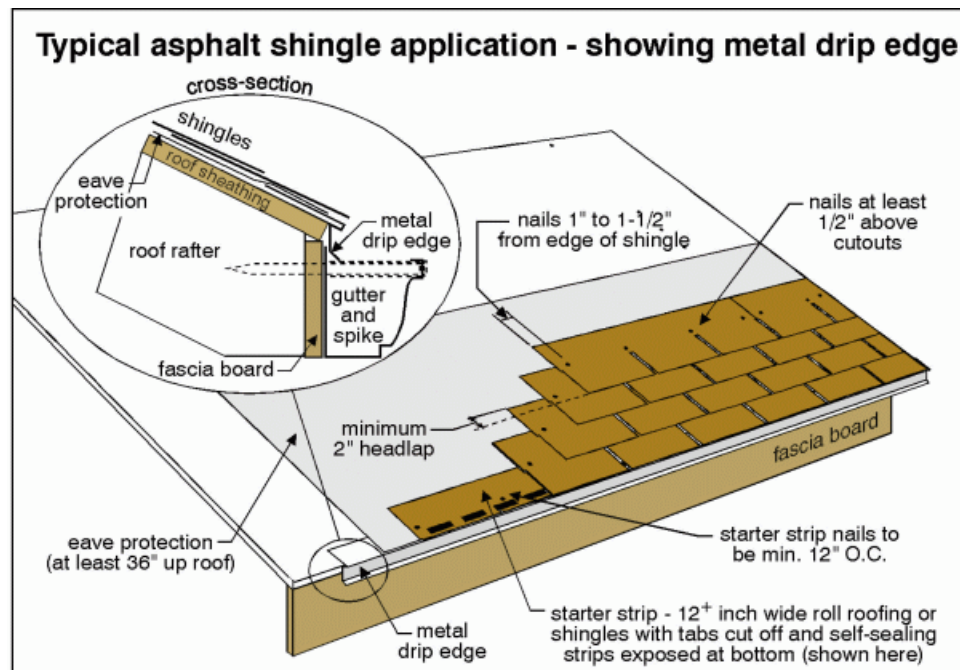
3. Condition: • [Missing](#)

Implication(s): Chance of water damage to structure, finishes and contents

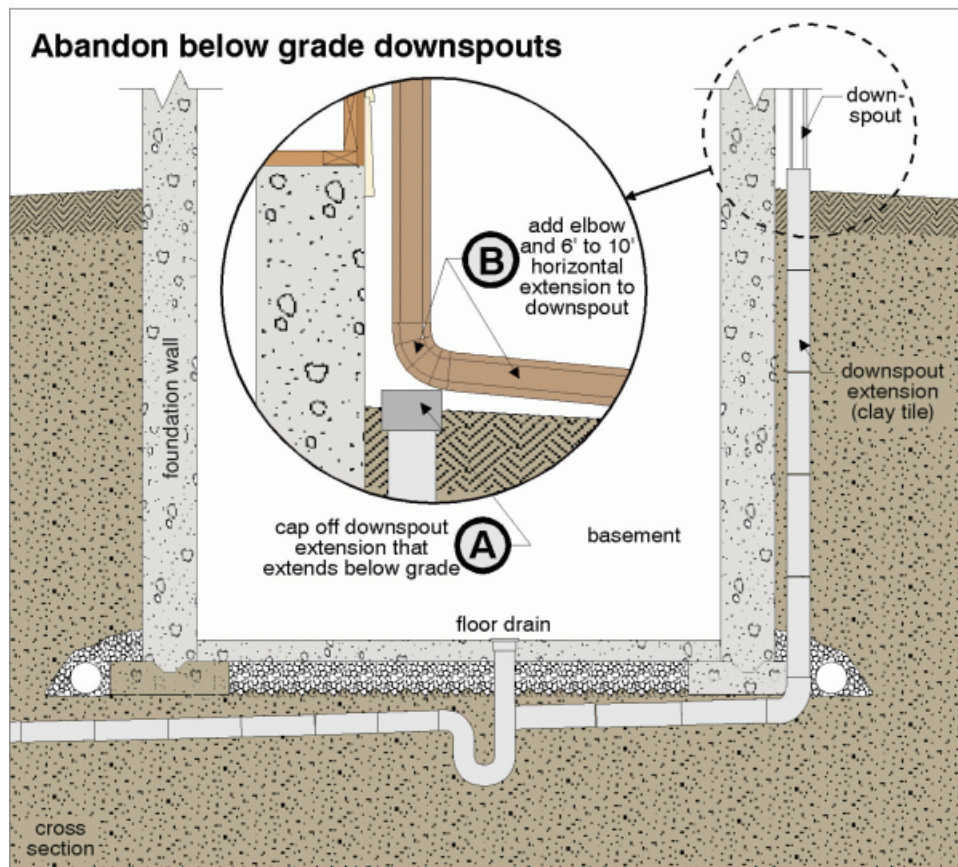
#### **5. Condition:** • Discharge below grade

Part of maintaining your home is preventative maintenance. The building is noted to have downspouts(roof drainage system) that drain below grade that would expect to connect to a perimeter drainage system(not visible). Recommend having a licensed drain specialist evaluate and complete a visual scope of the drainage system to ensure of limited drain blockages, and as needed, the scope of work and costs of repairs, and enquire on routine maintenance/inspections

**Implication(s):** Chance of water damage to structure, finishes and contents

**Task:** Service

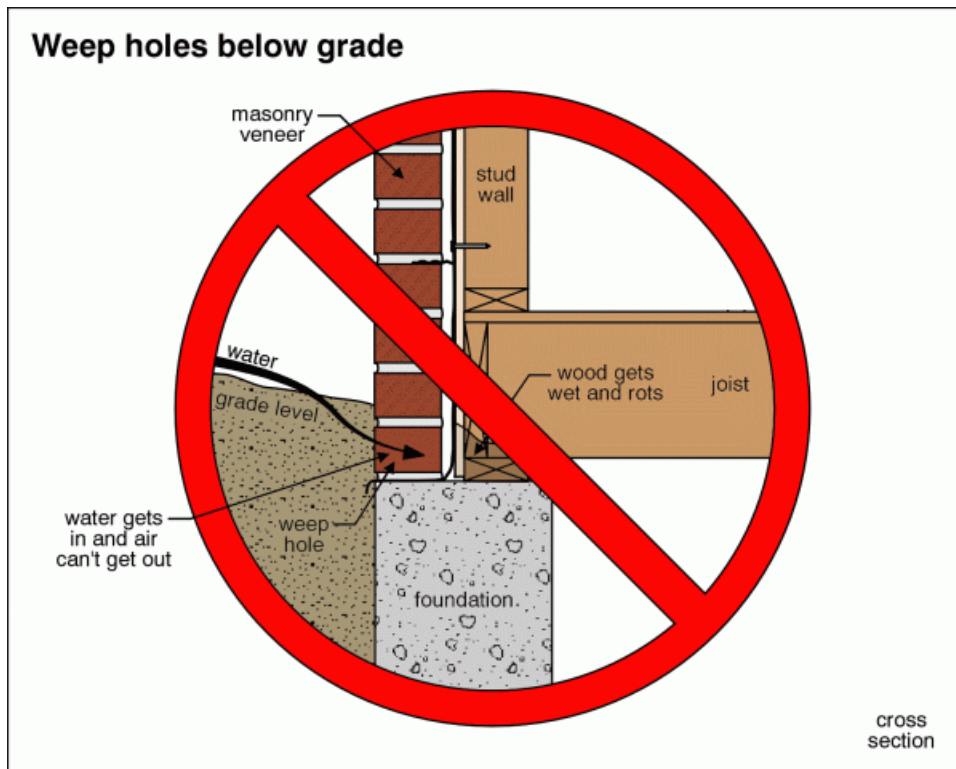
**8. Condition:** • [Missing, ineffective weep holes or flashings](#)

**Implication(s):** Chance of water damage to structure, finishes and contents | Material deterioration

**Task:** Improve Service Clean

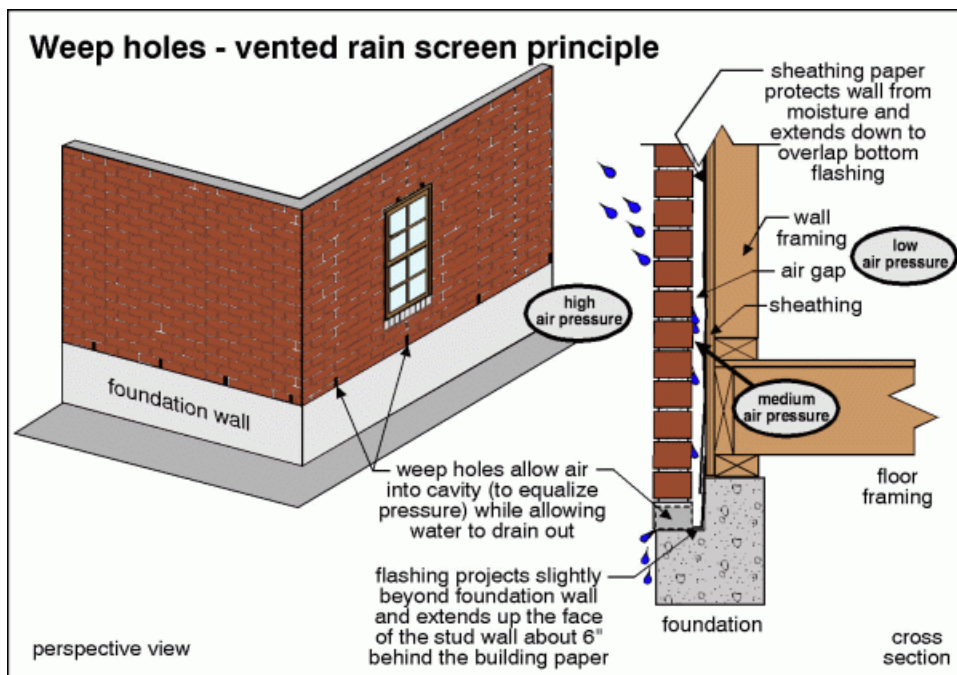
9. Condition: • [Too close to grade](#)

Implication(s): Chance of water damage to structure, finishes and contents | Weakened structure | Rot

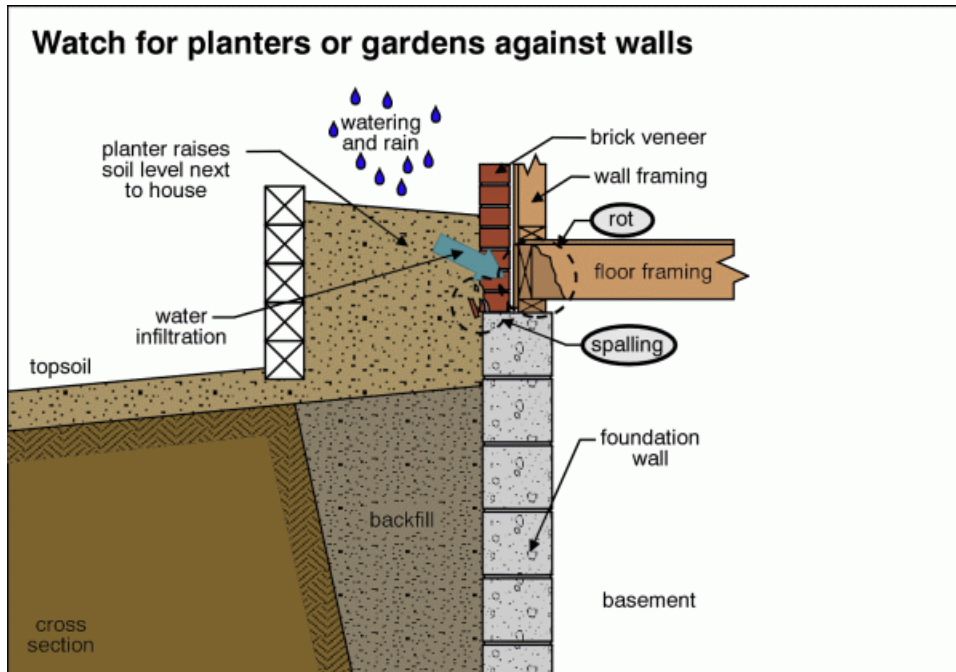
13. Condition: • [Planters and gardens against walls](#)

Recommendation to clear all vegetation touching or close proximity to exterior walls and eaves. Implications include damage to under ground perimeter drainage, penetration into eaves from vines or branches, as well as presenting access points for pests and vermin. A yearly maintenance plan is recommended and is best in the early growing season to mediate growth and expansion of vegetation.

**Implication(s):** Chance of water entering building | Chance of damage to structure | Chance of structural movement

**Task:** Remove

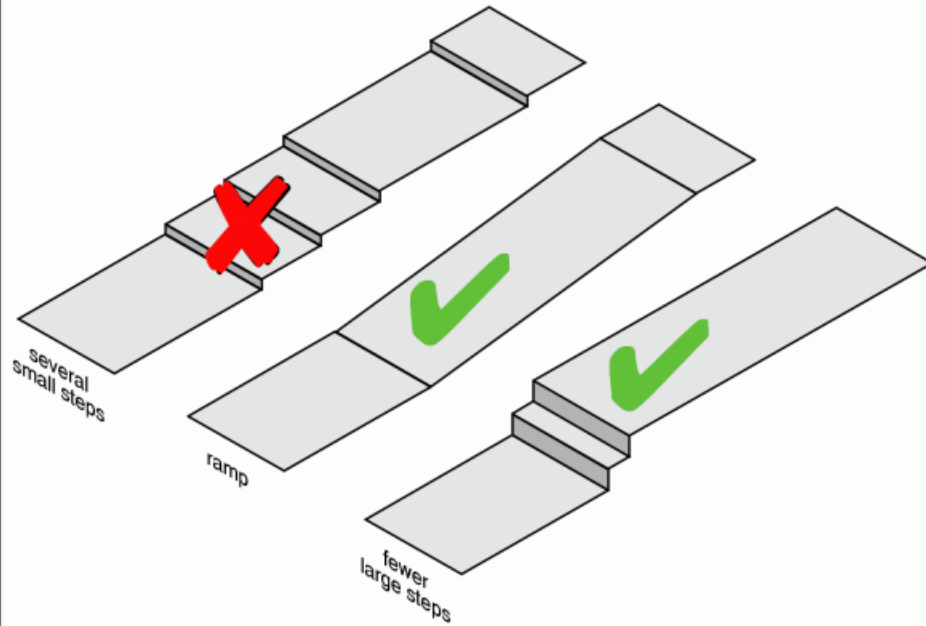
## Walkway steps

14. Condition: • [Uneven \(trip hazard\)](#)

**Implication(s):** Physical injury

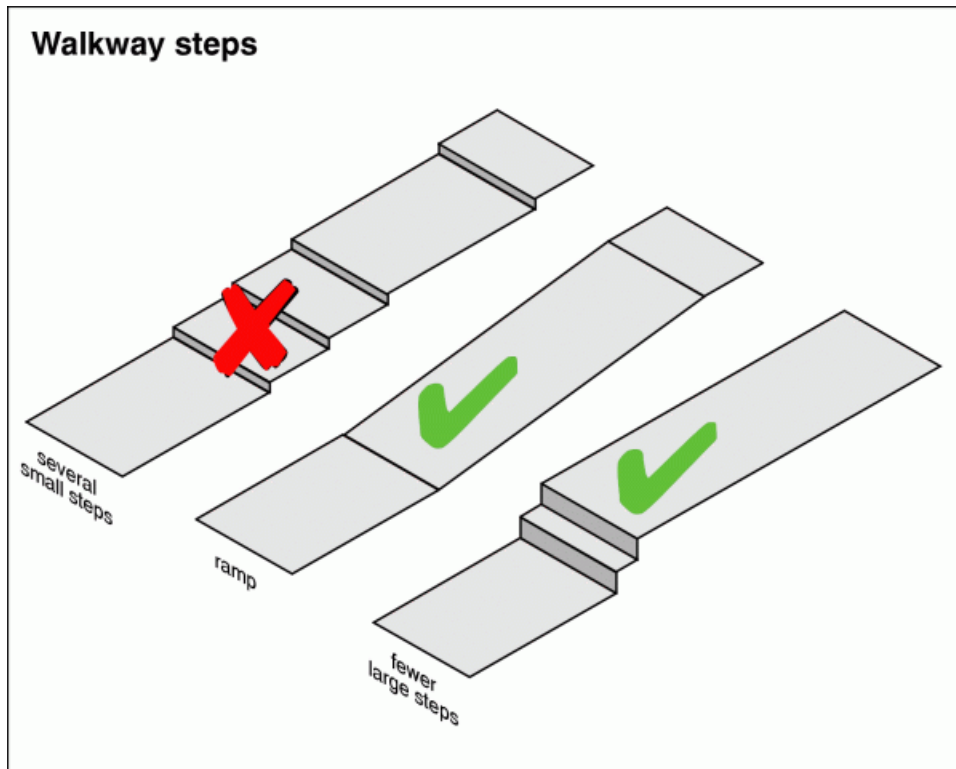
15. Condition: • [Cracked or damaged surfaces](#)

Implication(s): Trip or fall hazard

16. Condition: • [Uneven \(trip hazard\)](#)

Implication(s): Physical injury

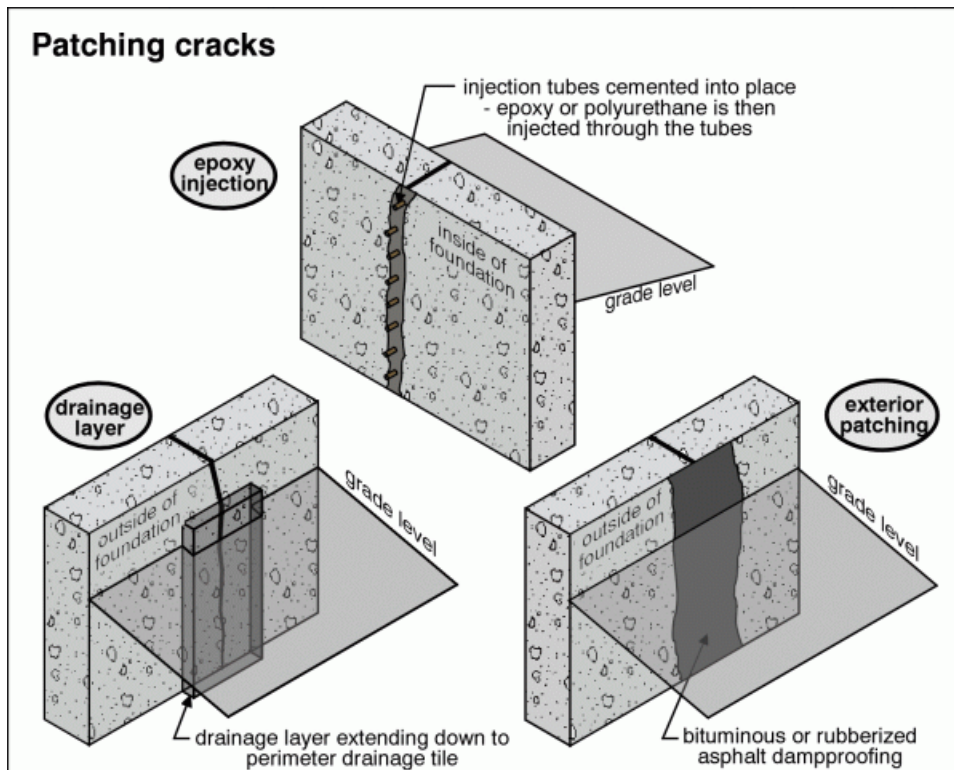
**18. Condition:** • Typical minor cracks

**Implication(s):** Chance of water entering building

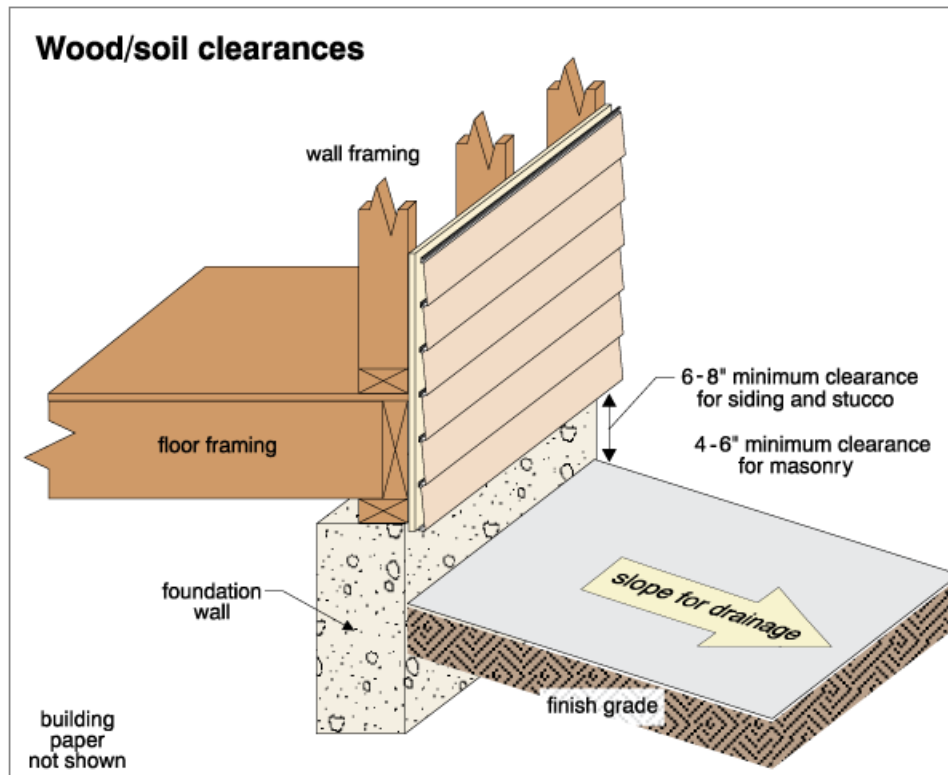
19. Condition: • [Masonry or wood too close to grade](#)

Implication(s): Chance of damage to structure

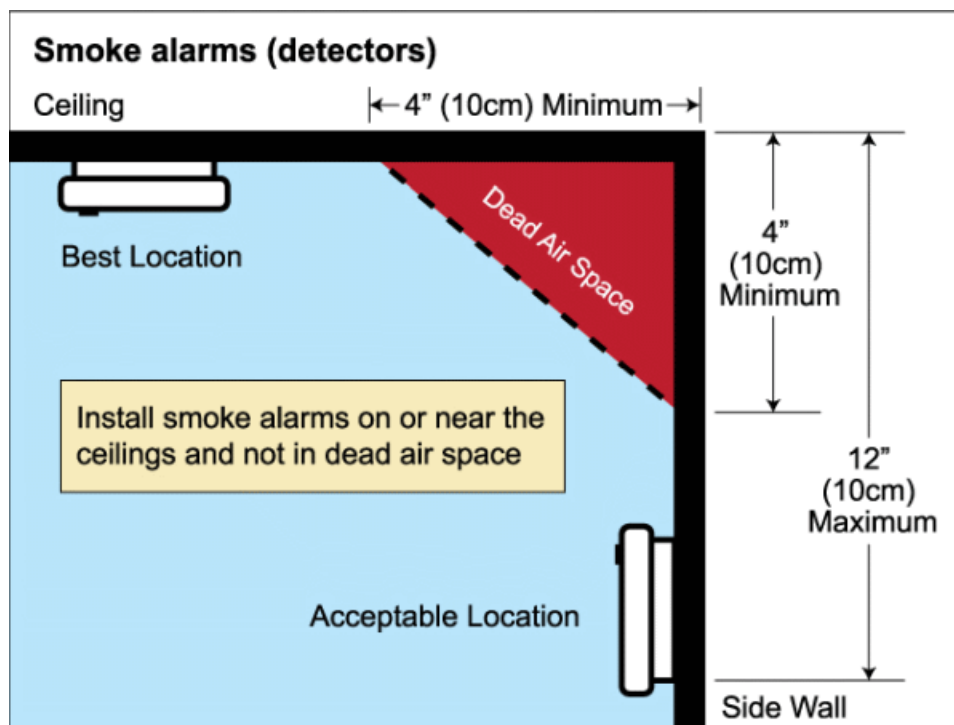
**26. Condition:** • not visible, missing or close to expiring, need testing or replacing

**Implication(s):** health and safety concerns, they save lives
